MOLAB User Report

Project Title: MacSTONE: Effects of fire on building stone at the Mackintosh School of Art, Glasgow, Scotland

Venue: The Library of the The Mackintosh Building of the Glasgow School of Art, Scotland, June 20th to 24th 2016.

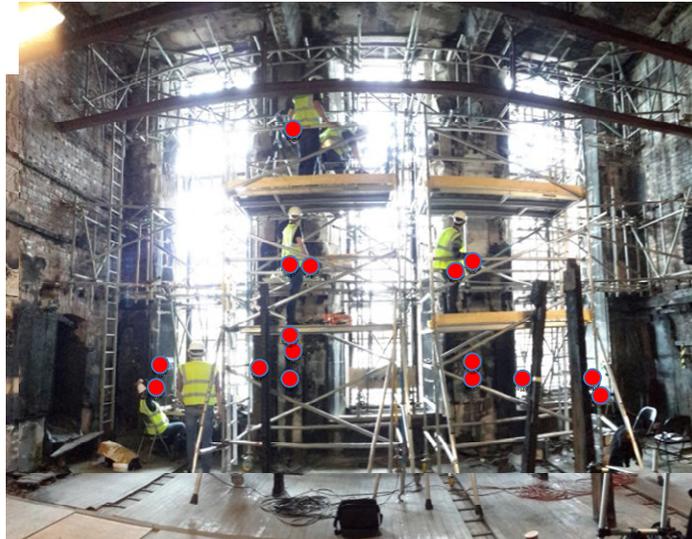
In the devastated library space, damage is evident on the sandstone walls, notably the piers between the windows and the walls either side of the tall windows. Surface spalling and cracking of the stone will require significant intervention as part of the restoration effort. The loss of cultural, historic and artistic value, due to the fire, is indeed tragic, but the damage to the structural fabric of the building also behoves us to understand the material impact of the disaster to assist in the restoration and recovery activities. The purpose of the MOLAB visit was to perform analysis on the affected walls to understand the effects of the fire on the stone and to evaluate the degree of damage. It is hoped this will contribute to decision-support for the repair works.

Analysis was performed in 17 locations on the wall (Fig. 1), and on specimens of fallen fire-damaged and also taken-down stone, with known locations. For most of these locations analysis was performed using all methods. The stone is from the Giffnock quarries in Glasgow (quartz arenite, secondary

Figure 1: overview of the damaged sandstone piers in the Library of the Mackintosh Building. View is facing west, and the red dots indicate the location of analysis points, including of taken-down stone (i.e. not an in-situ measurement) for the highest located point.
